CAN DO, WILL DO, HAVE DONE

Capt Ryan Novotny is a project engineer with the 819th RHS, Malmstrom AFB, MT.

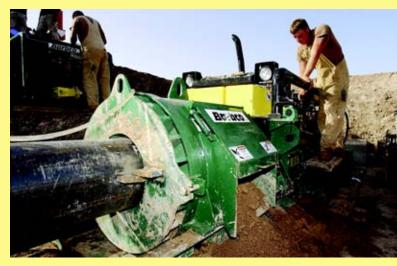
A1C Nathan Laidlaw operates a horizontal boring machine. The machine bores large holes for utility crossings under the airfield surface, eliminating trenching. (Photo by SSgt Tony R. Tolley)

The lighting design required airfield utility cuts that are costly in time and materials. We purchased a directional drill to cut costs and sent a team to attend school to learn the process. The machine has a rotating cutter head that spins, and the cuttings flow back to the beginning of the drill in a drilling mud. The directional drill cuts an opening wide enough to fit the required number of conduits, and they are pulled through to manholes that are set on either end.

"Some drills you could do in a heartbeat, but others were a real challenge," said SSgt Casey Kuhn, lead directional driller. "Overall, drilling saved us lots of time." The team perfected the process and saved 4,000 man-hours during the project in airfield trenching and repairs.
